WWF
REPORT

COMMUNITY CLIMATE CHANGE VULNERABILITY ASSESSMENT

FLORENCEVILLE-BRISTOL, HARTLAND AND WOODSTOCK

Published: January 2017

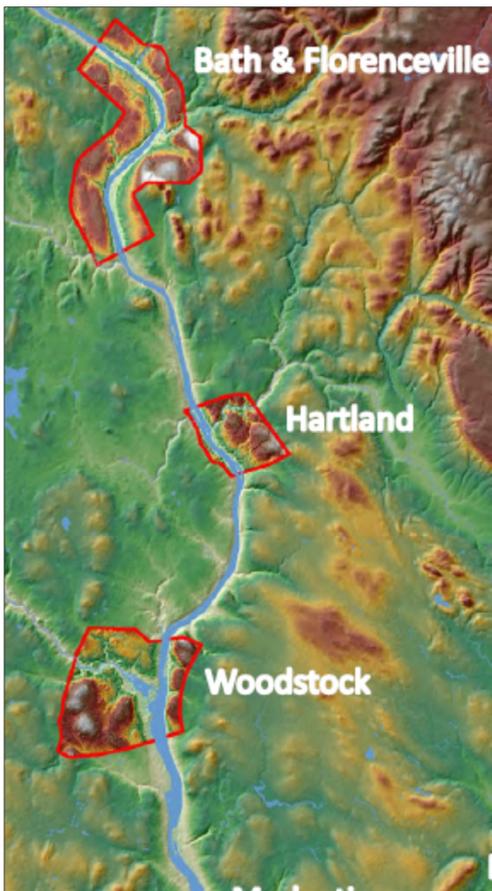
The Bare Earth DEM is then used to determine the Depth-to-Water Index and Wet-areas Maps. Surface waters (blue) are given a reference of zero, and referred to as flow channels. Those areas of surface water are joined digitally at the high water mark and soil, geological and elevation information is considered in order to determine where the water likely sits below the surface, between the surface water showings (Figure 20). The difference between the Bare Earth DEM and the determined subsurface water is called the Depth-to-Water Index and is indicated on a visualization where surface water is zero, and other depths of water below the surface are classified by blue hues, in our case representing 0-10 centimetres (cm) below the surface, 10cm – 25cm below the surface, 25 – 50cm below the surface and 50cm – 1 metre below the surface. The result of this process is referred to as Wet-areas Mapping (WAM).

Figure 19. This Bare Earth Digital Elevation Map (DEM) representative of ground elevation (blue – open water, green low elevation to red highest elevation). The red outlines indicate the land area to which the Wet-areas Mapping and Hydro-risk analysis has been applied. Source: Arp et al. 2015

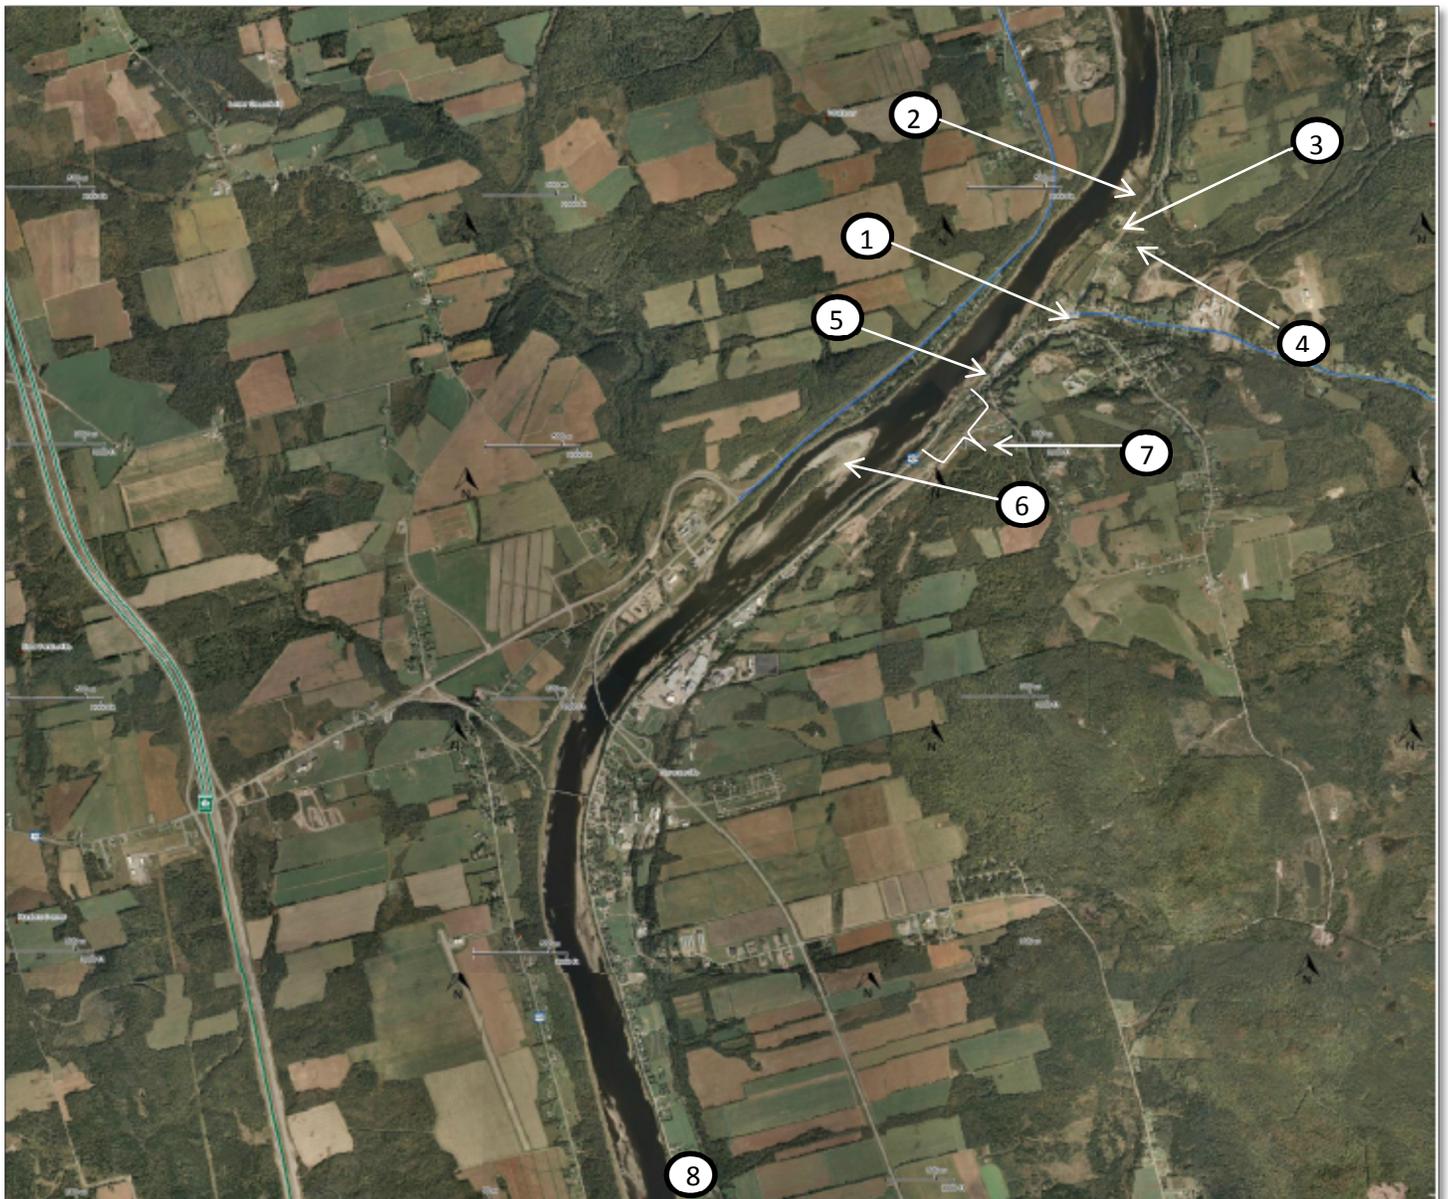
Figure 22. Florenceville-Bristol map indicating impact areas 2008 – present.

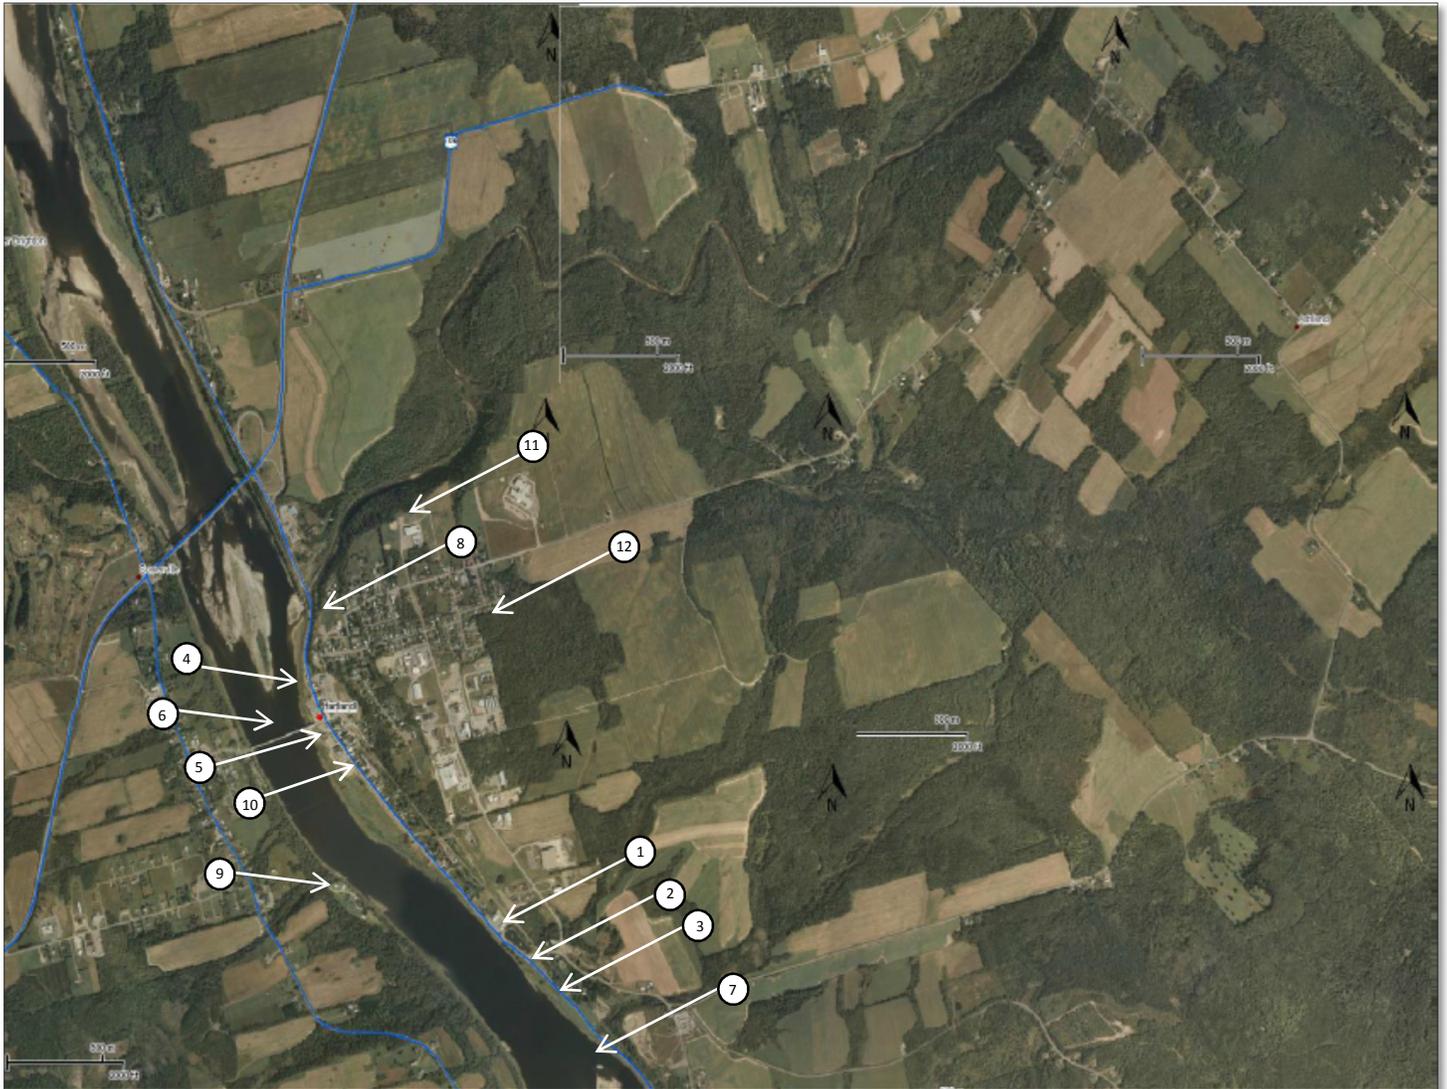
Figure 23. Hartland map indicating impact areas 2008 – present.

- 5 = Baptist Church - basement floods
- 6 = Covered Bridge – concern for damage to bridge due to ice or flooding
- 7 = Sproul’s Island - silt around island has made the river very shallow
- 8 = Well Field - water supply - potential problem
- 9 = School/Summer camp – concern for flooding risk
- 10 = Fire Station - access problem in flooding
- 11 = Arena – snow load risk
- 12 = Greenbelt - helps to stop erosion of agriculture areas

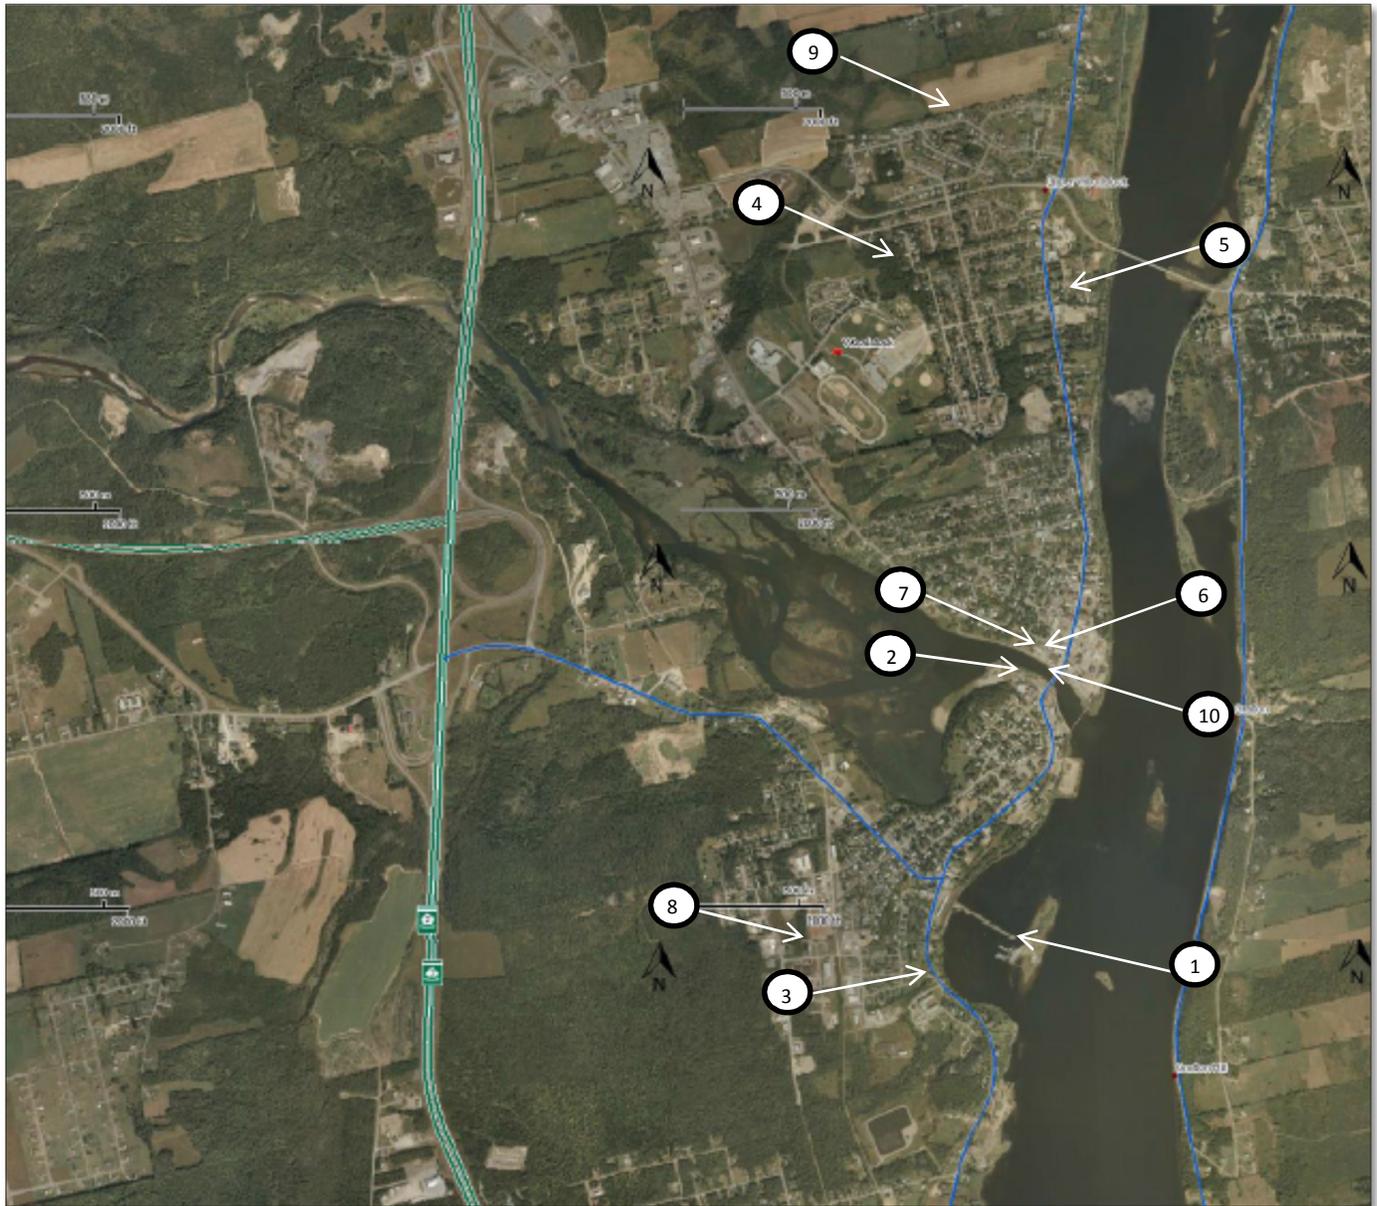
Figure 24. Woodstock map indicating impact areas 2008 – present.

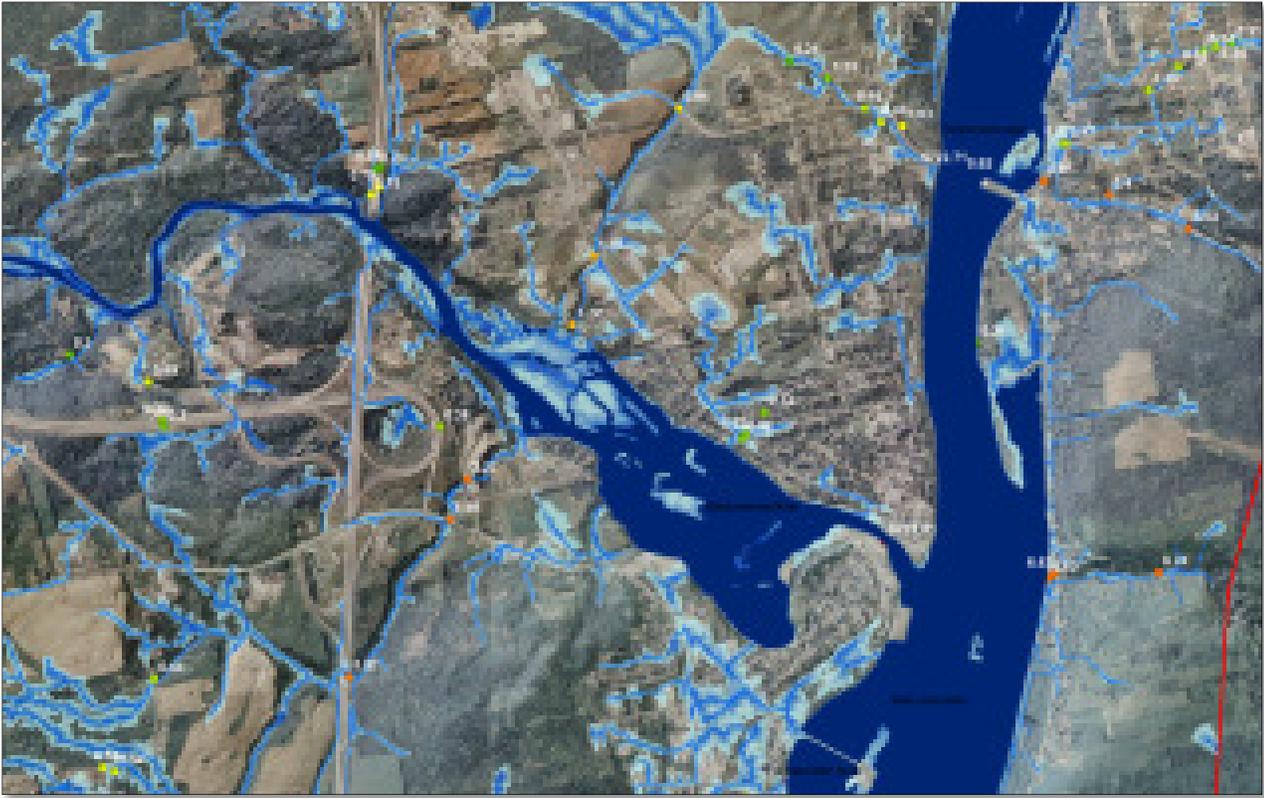
Figure 31. Woodstock, 4 ha flow initiation. Source: Arp, Castonguay 2015

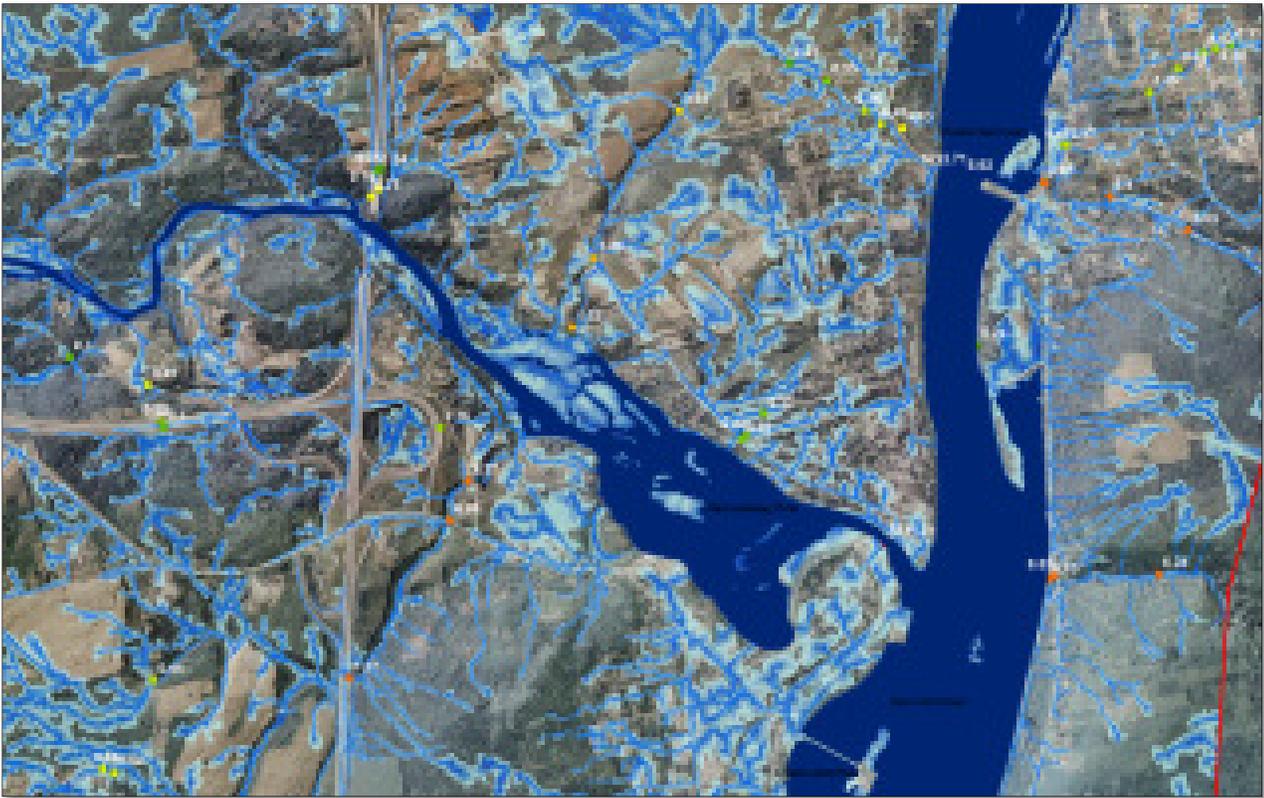
Figure 32. Woodstock, 1 ha flow initiation. Source: Arp, Castonguay 2015

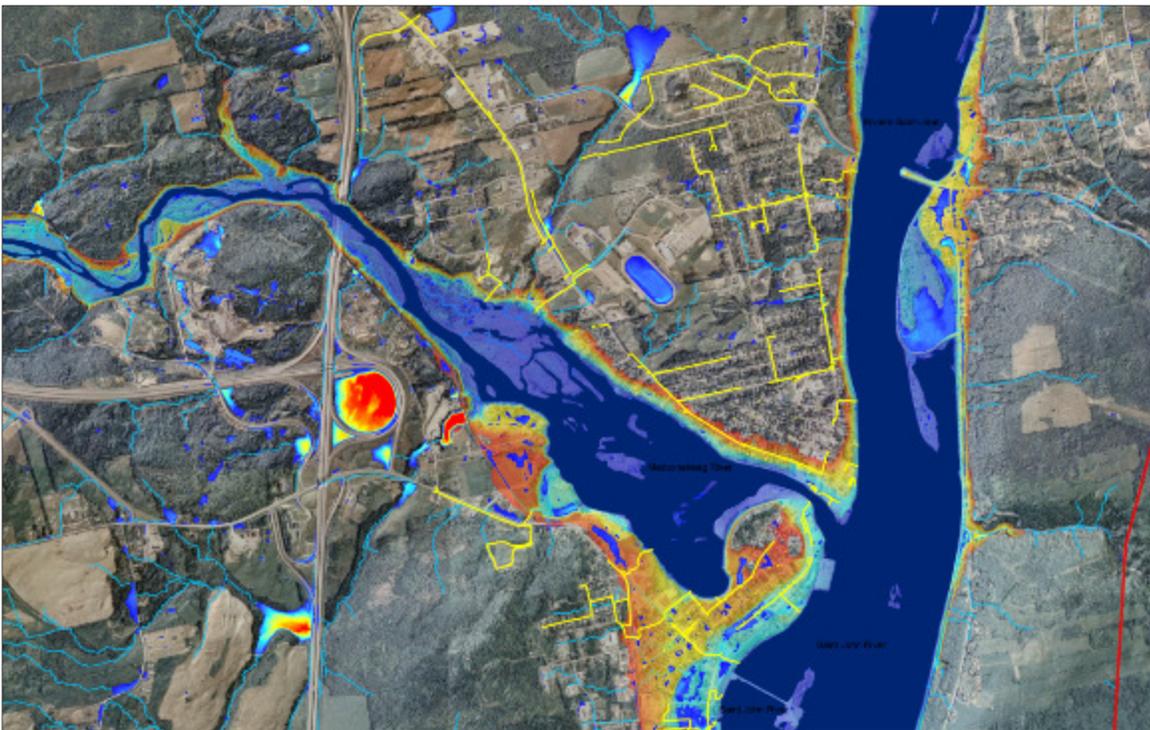
Figure 34. Woodstock LiDAR DEM – 4ha Flow, Sinks, Drainage Infra. – P. Flooding @ 15m. Source: Arp and Castonguay 2015

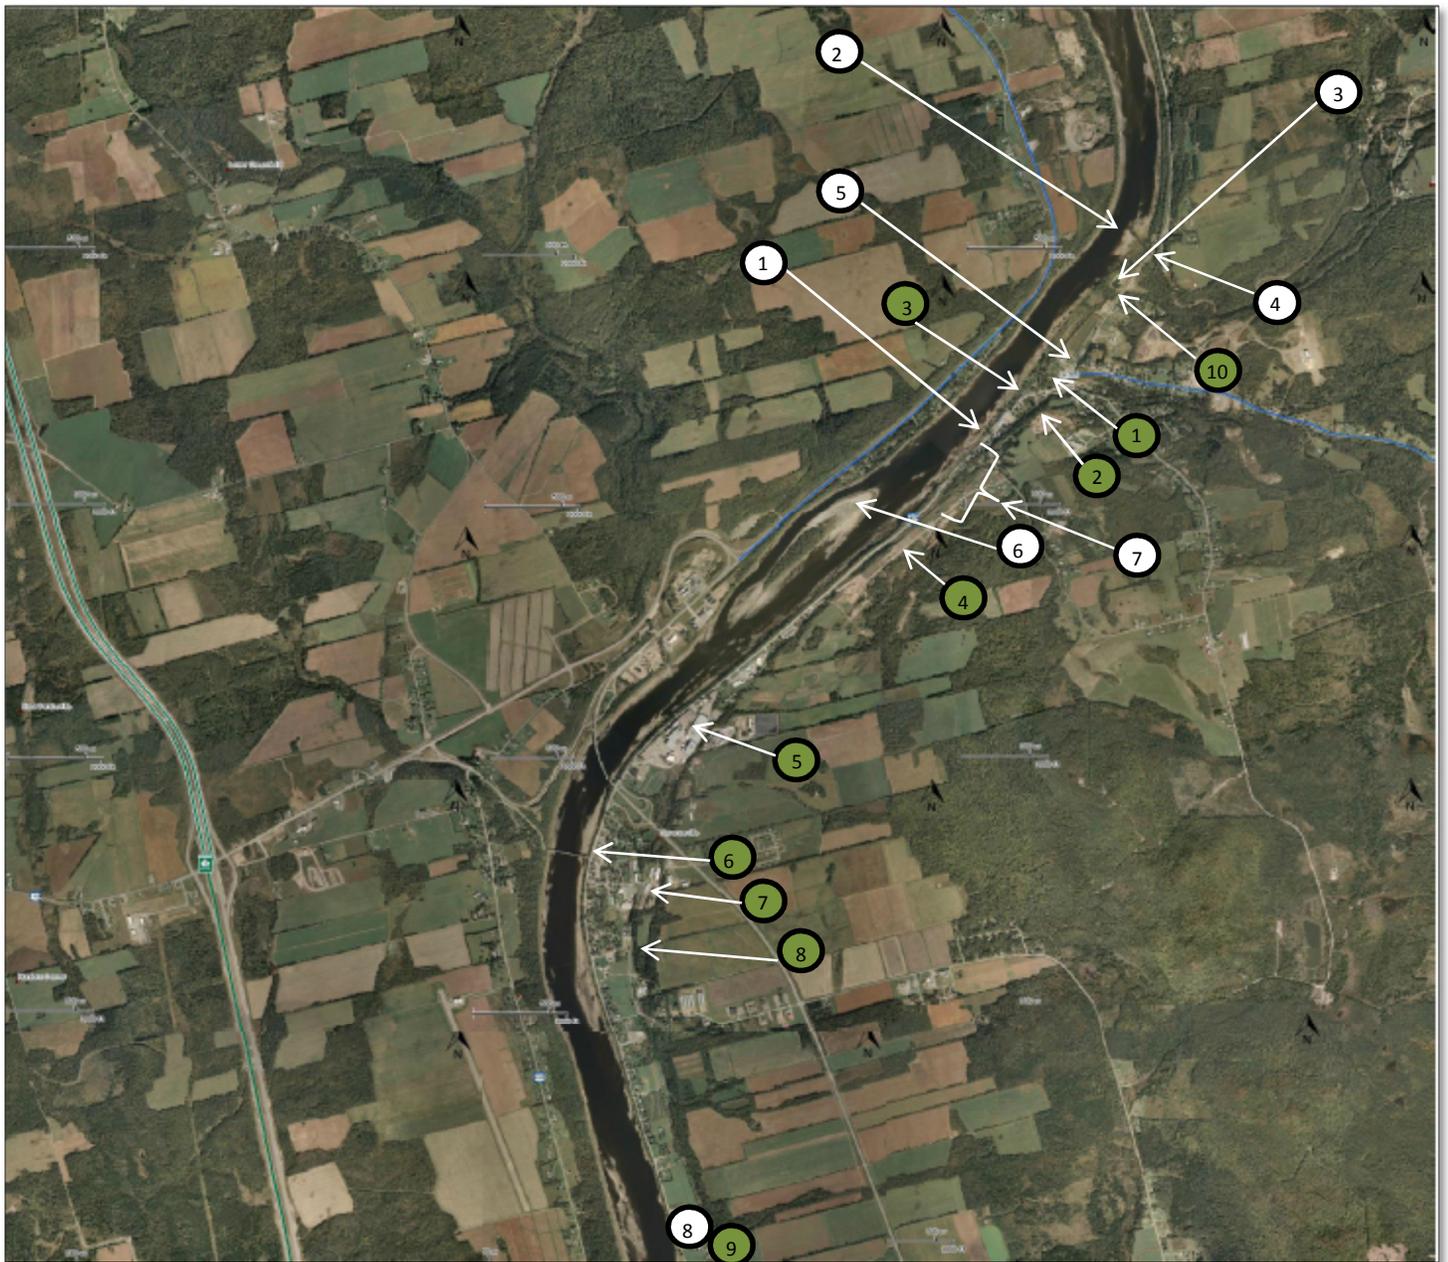
Figure 39. Florenceville – Bristol map - physical impacts (indicated in white) and environmental areas (green).

- | | |

| 4 – Hitchcock Place - Buried tanks at one point | 9 – Lagoon |
| 5 – McCains – Methane Lagoon, LNG | 10 - Lagoon |

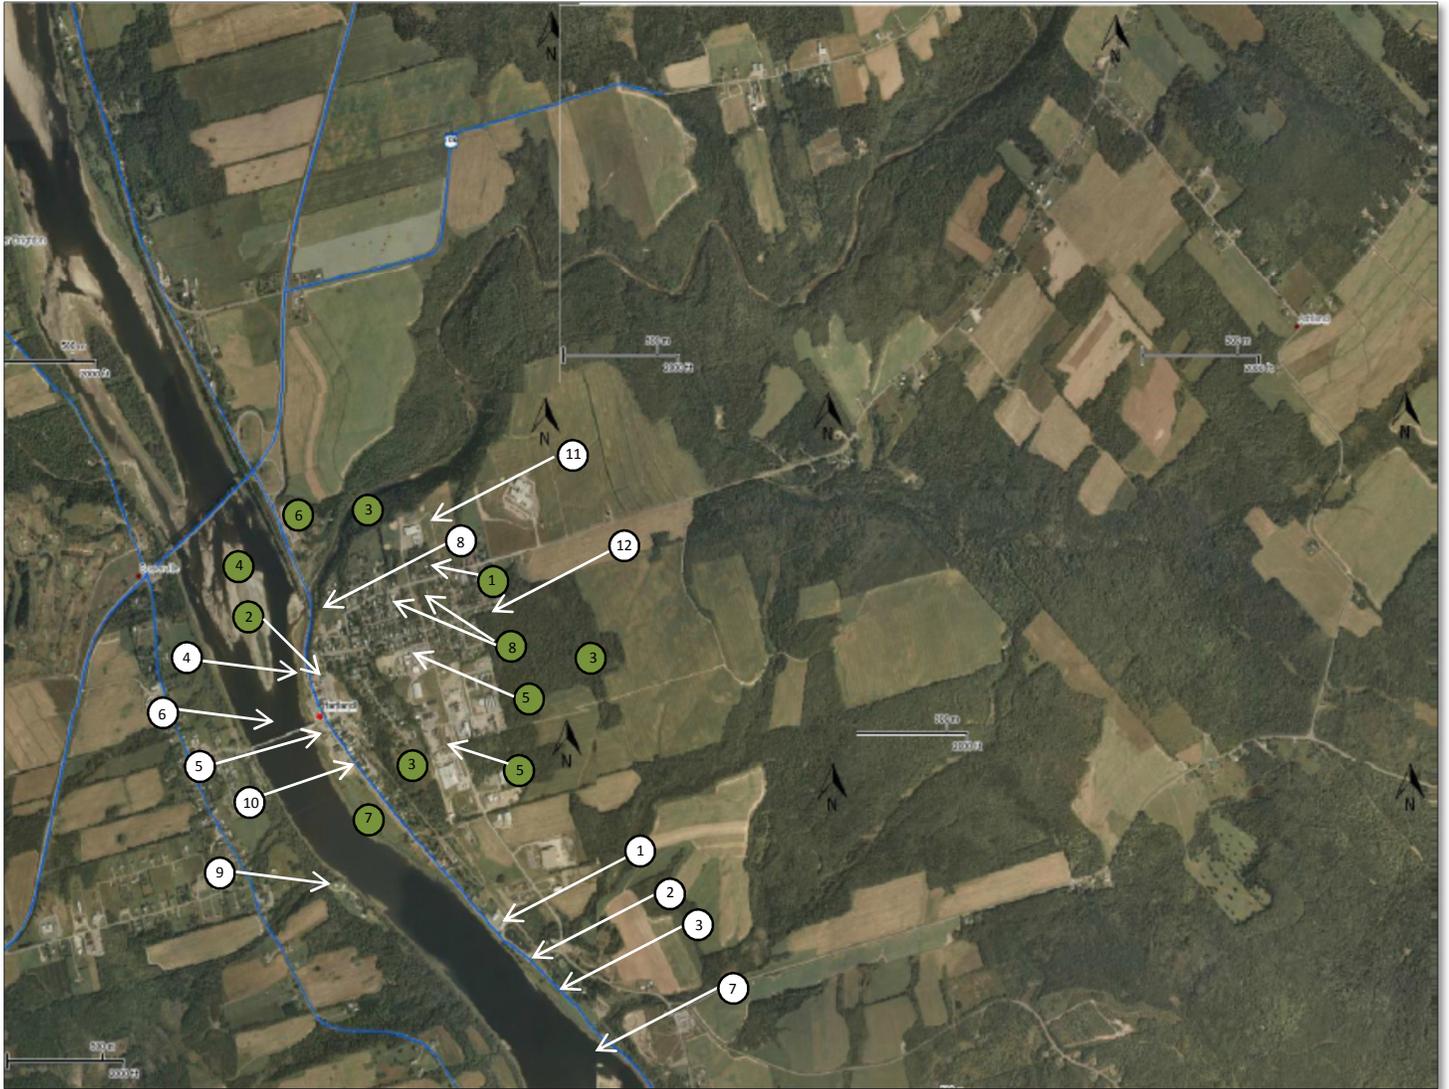
Figure 40. Hartland map - physical impacts (indicated in white) and environmental areas (green).

- 1 – Old gas station – fenced in, but tanks possibly still in ground
- 2 – Old Craig Manufacturing Lot – contaminated soils
- 3 – Greenbelts – environmental buffer
- 4 – Island – maintains river habitat
- 5 – Valley Equipment b>Hartland Agromart – hazardous materials storage
- 6 – Irving Gas Station – fuel storage
- 7 – NB Power Flood Zone – buffers flooding from residents on Main Street
- 8 – Wet area all residents

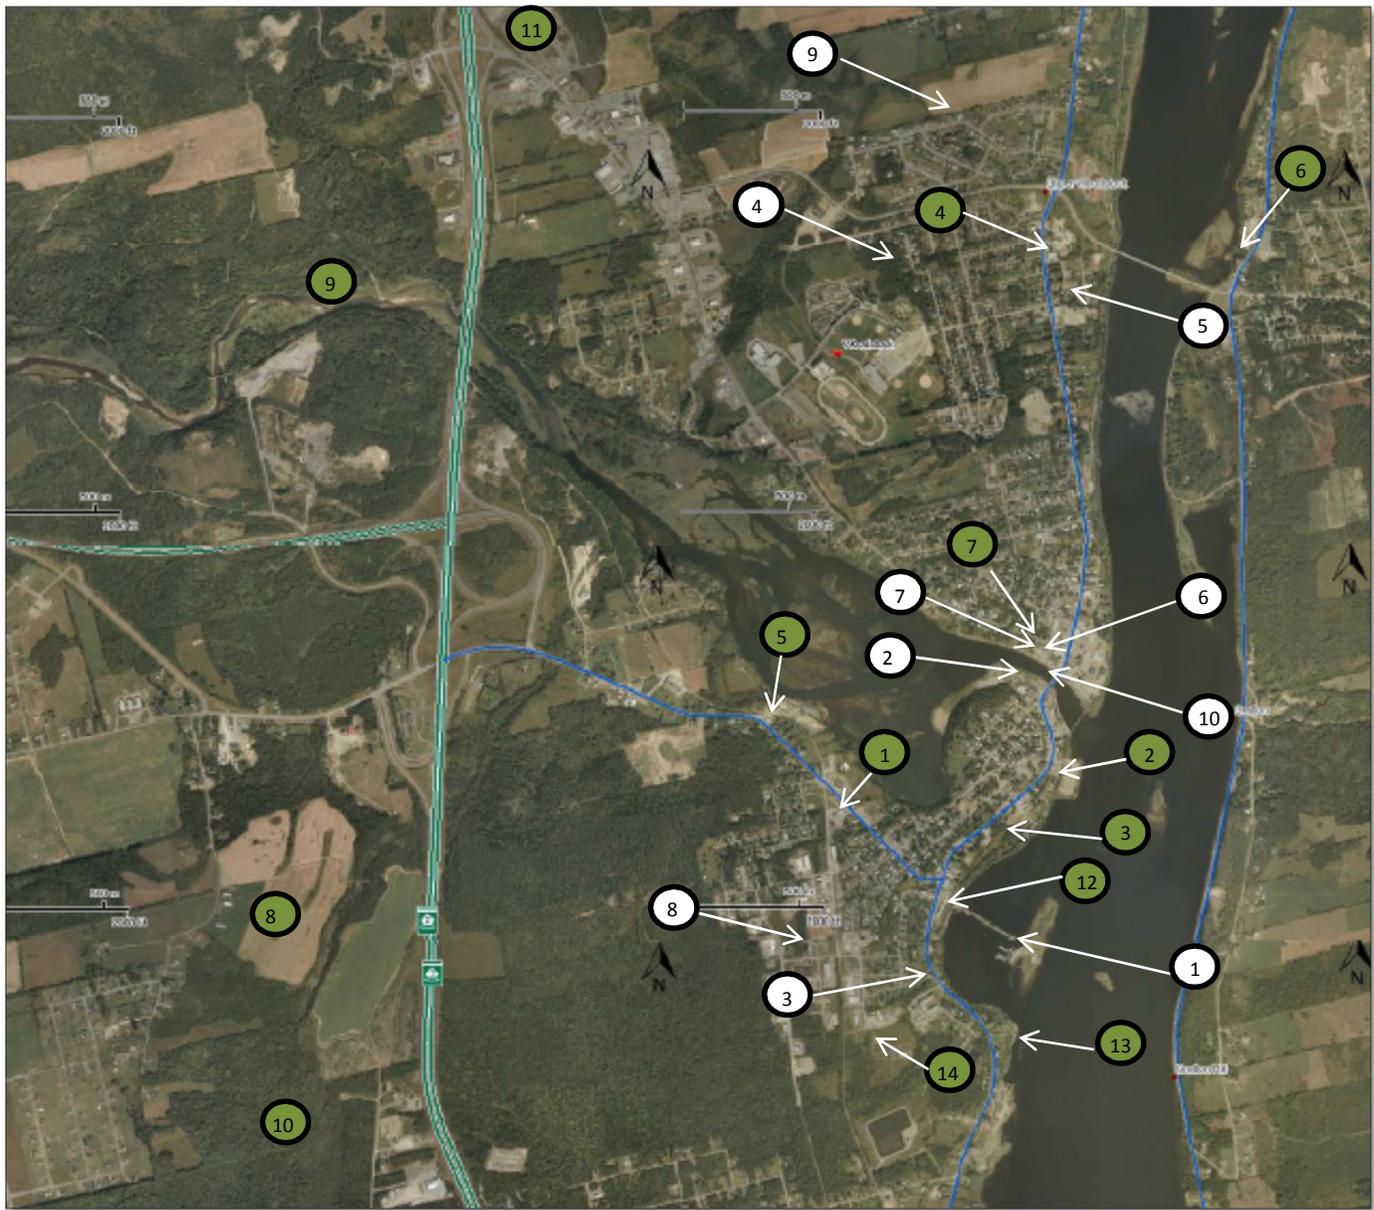
Figure 41. Woodstock map - physical impacts (indicated in white) and environmental areas (green).

- 1 – FMR Irving Plant – possible oil contamination
- 2 – FMR – Imperial Oil - possible oil contamination
- 3 – FMR – CP Rail - possible oil contamination
- 4 – Mortgage Pro’s FMR Wilson Equip - possible oil contamination
- 5 – Cement Plant - possible oil contamination
- 6 – Maintenance Shop FMR DOT Depot – oil/fuel contamination
- 7 – Dry Cleaner – chemical storage
- 8 – Sustainable Community Design Subdivision
- 9 & 10 – Nature Preserve
- 11 – Connell Brook Watershed
- 12 – Fuel Storage – Marina
- 13 – Scrap Yard
- 14 – Outdoor tire storage
